Spoon River at Seville, IL

Study Reach.--The channel reach under consideration is the meandering natural river, shown in the quadrangle map on the top left. A study reach, approximately 2,850 ft long, was selected as the segment extending from 150 ft upstream of the USGS gage to 200 ft downstream of an abandoned bridge about 2,500 ft downstream from the highway. There are eight surveyed cross sections (surveyed by the Illinois Department of Natural Resources, August 2003) available for evaluating the channel geometries in the study reach. The alignment of the study reach, approximate variations in channel width and bank conditions, and locations of surveyed cross sections are shown in the aerial photo on the top right. Cross-sectional plots at four locations, river station (RS) 7, 6, 4, and 3 are considered representative of the study reach (see plots above).

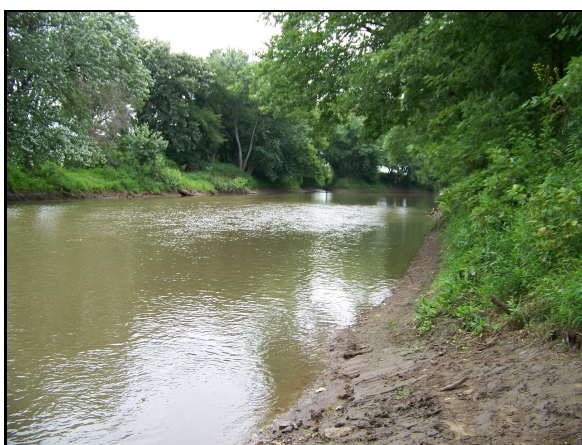
05570000 Spoon River at Seville, IL
Low flow, looking upstream from left bank

Description of Channel.--This channel is natural. The bed materials consist of primarily silt, sand, and a moderate spread of gravels. The channel can be described as trapezoidal in shape. The bottom width of the channel averages about 150 ft. The banks are generally firm soil densely lined with trees on the upper portion of the banks, so much so that the trees overhang the river. The bank heights are approximately 20 ft and very steep in some places. The top width is about 175 ft. Overall cross sections can be considered relatively uniform in the study reach. The study reach is meandering with one sharp bend greater than 90 degrees.

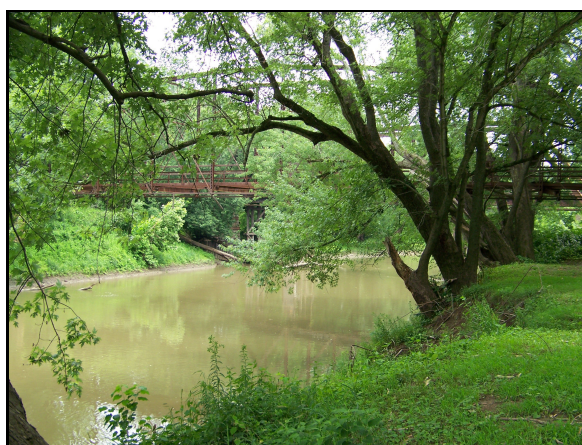
05570000 Spoon River at Seville, IL
Low flow, looking downstream at abandoned bridge

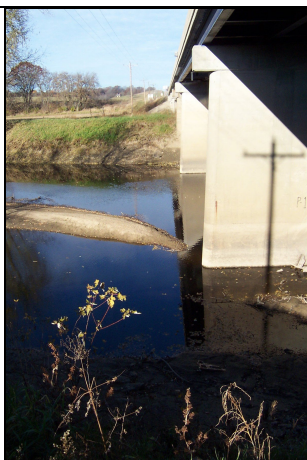
05570000 Spoon River at Seville, IL
Looking at right bank

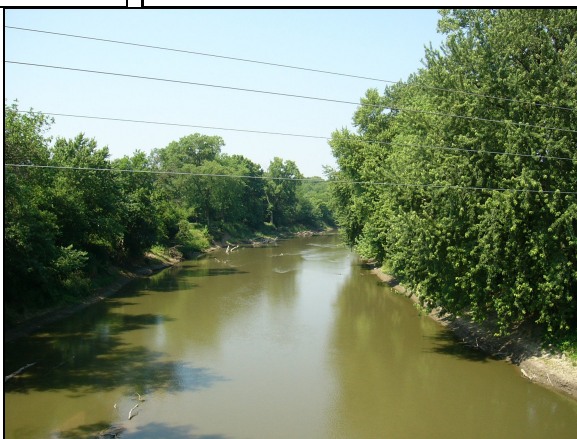
05570000 Spoon River at Seville, IL
Looking Downstream from Bridge

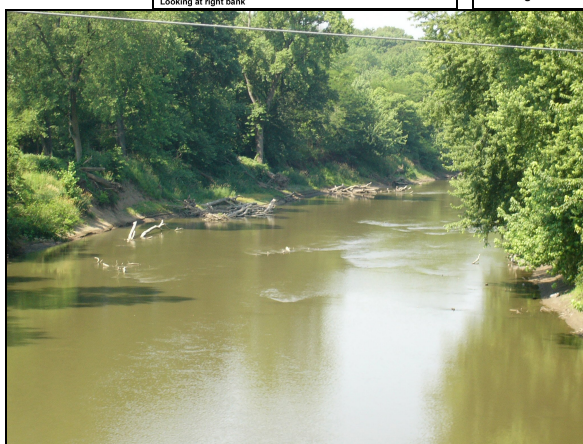
05570000 Spoon River at Seville, IL
Low Water Control one third mile Downstream

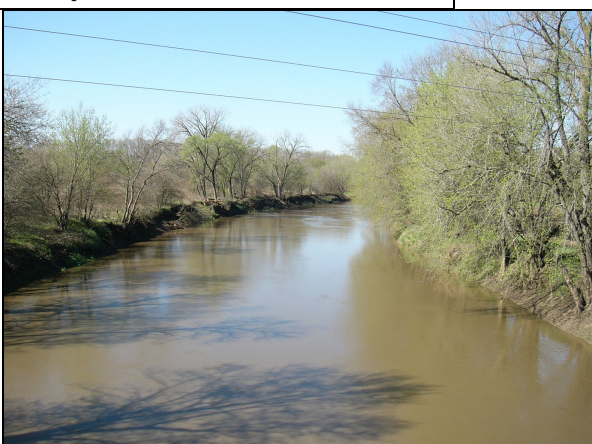
05570000 Spoon River at Seville, IL
Looking Downstream from bridge
